# Porches That Won't Rot

■ BY KEVIN M. MAHONEY

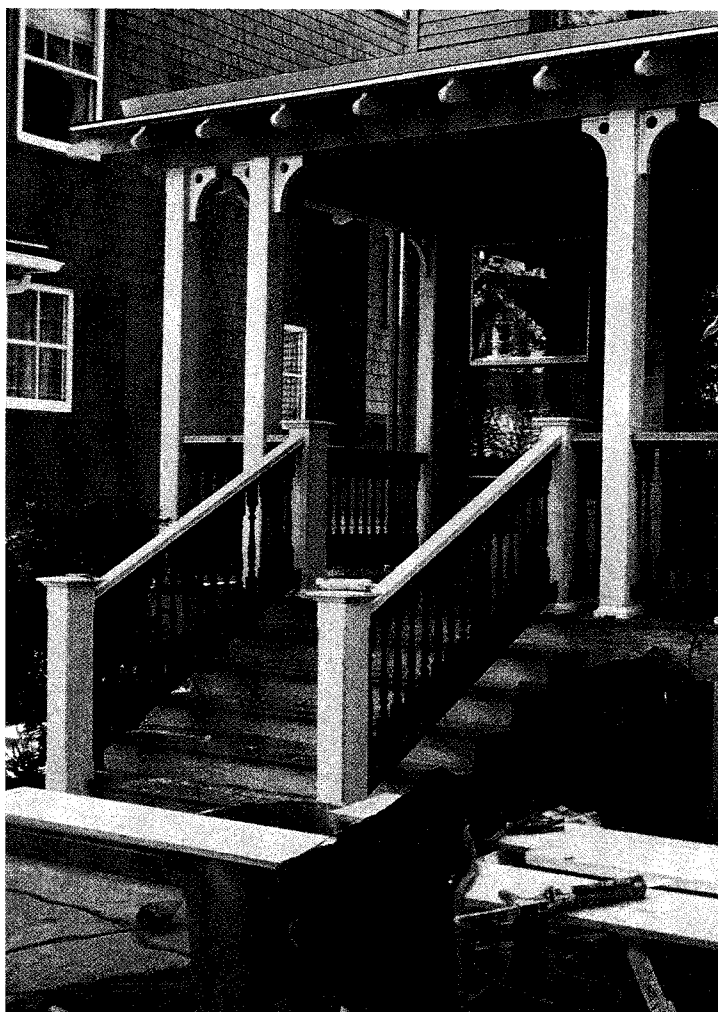
**At this Buffalo, New York, Victorian house, the front porch was rebuilt using techniques designed to eliminate trapped moisture that leads to rot.**

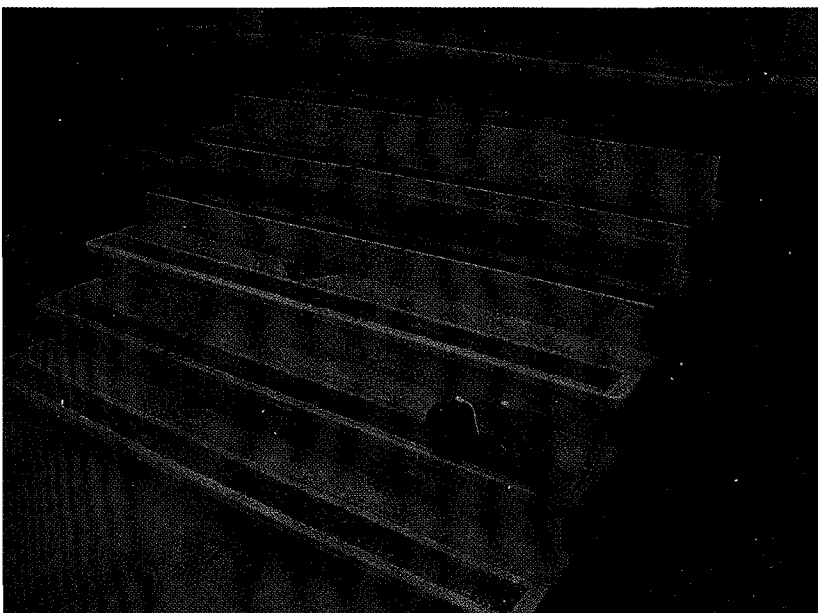
**trip along the front of each stair tread gets a coating of epoxy and crushed nut shells for good footing in poor weather. The furring at the top of the stairs separate the top riser from the board beneath it and prevent trapped water t could rot the structure.**
