# Porches That Won't Rot

■ BY KEVIN M. MAHONEY

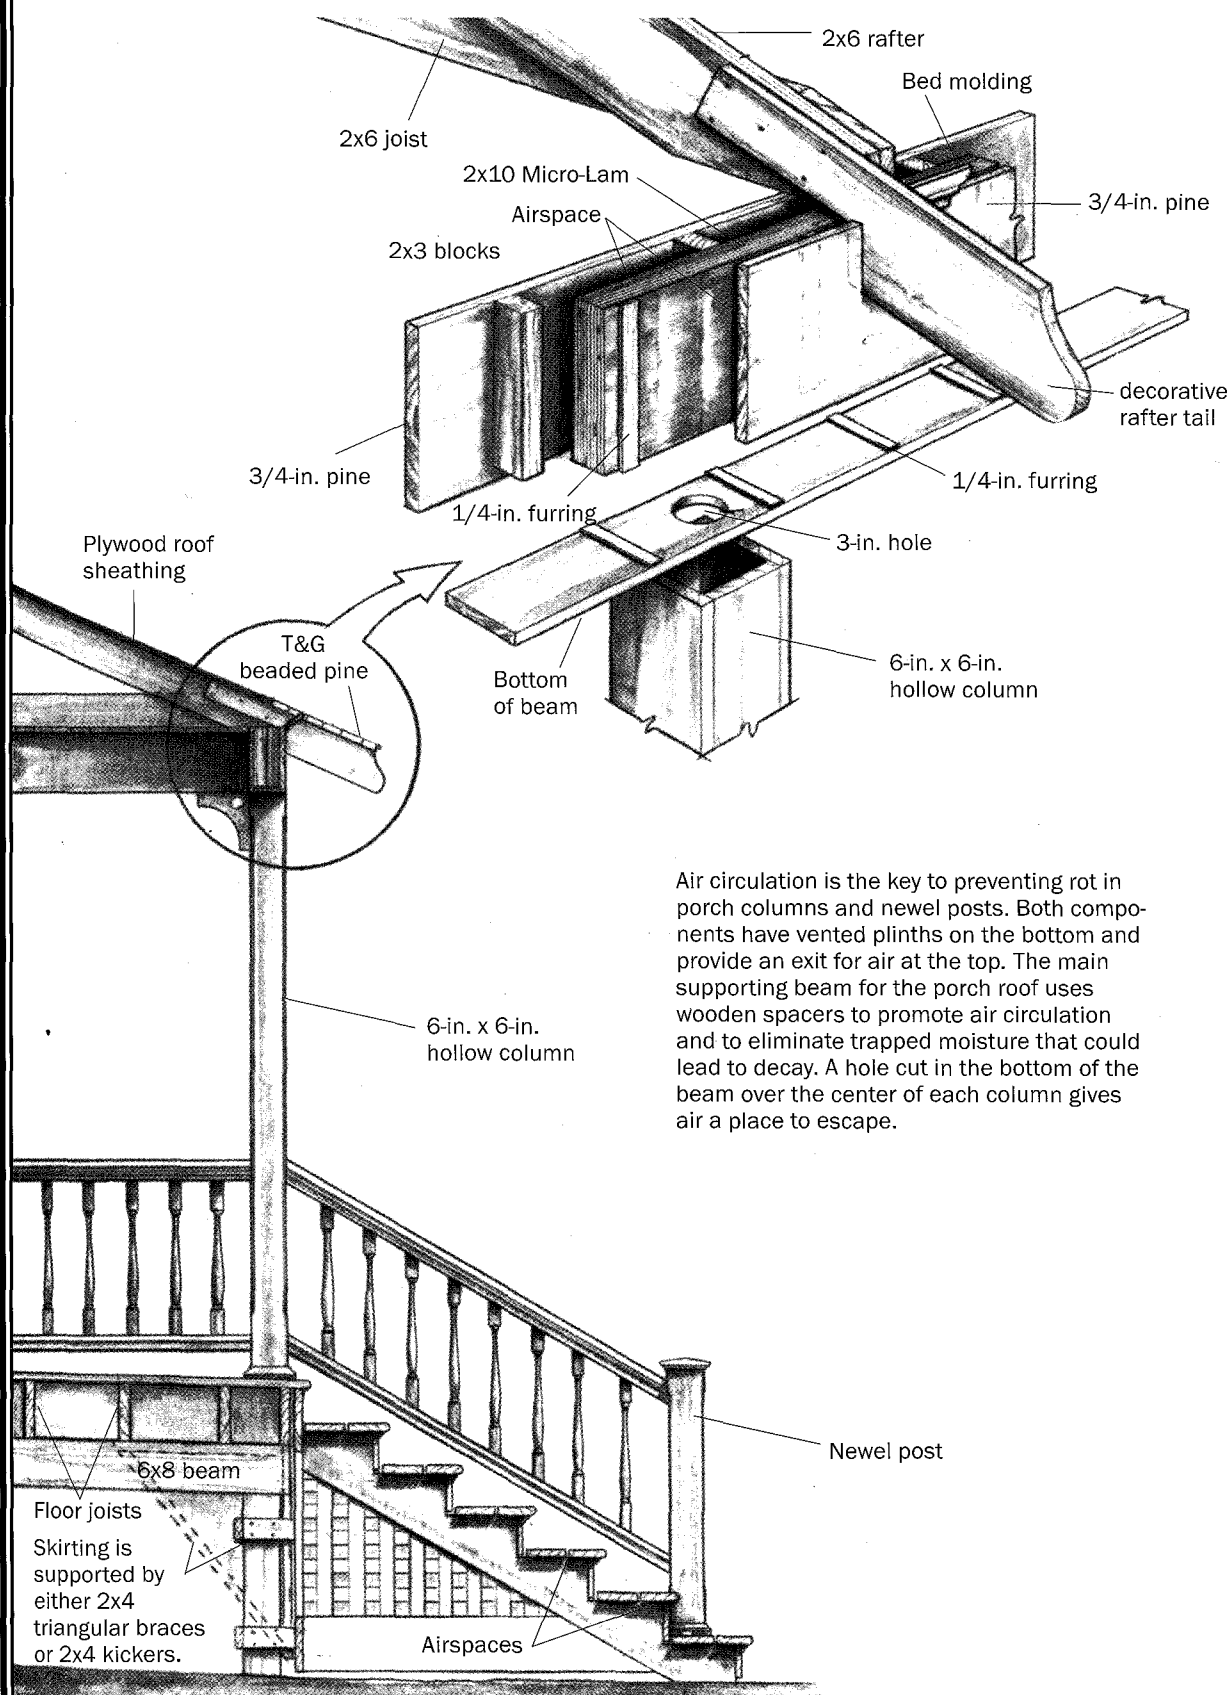
## Elements of a Rot-Resistant Porch

*The trick to keeping air moving through both the columns and the newel posts is wooden plinths we make ourselves.*

- Use pressure-treated lumber for deck and stair framing and for all components that come into contact with the ground.
- Encourage airflow beneath the porch and the stairs.
- Pitch the floor away from the house to allow water runoff.
- Seal all end grain.
- Vent columns and newel posts at both top and bottom.
- Avoid unnecessary wood-to-wood contact that can trap moisture.

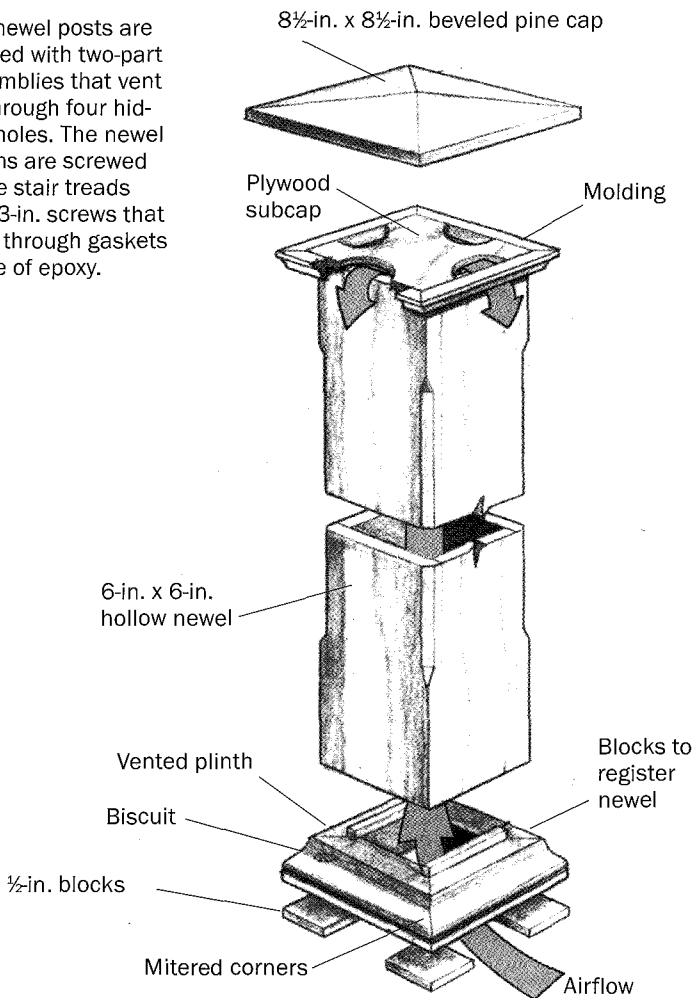
## Newel-Post Construction

The newel posts are capped with two-part assemblies that vent air through four hidden holes. The newel plinths are screwed to the stair treads with 3-in. screws that pass through gaskets made of epoxy.

The trick to keeping air moving through both the columns and the newel posts is wooden plinths we make ourselves. Making the plinths takes time, but they add a finished look to our porches (compared to commercially available metal vented plinths), and we can make them any size we need. We start with a base made from shaped  $5\frac{1}{4}$ -in. by  $2\frac{1}{2}$ -in. clear pine. We miter and spline the corners and glue the base together with epoxy, leaving a square hole in the middle for air to enter. We glue four  $2\frac{1}{2}$ -in.-square by  $\frac{1}{2}$ -in.-thick blocks to the bottom corners for feet. To the top of each plinth we then glue two blocks of wood that slide into the posts and prevent lateral movement. Once completed, each plinth gets two coats of marine epoxy. Although I don't do it, some builders install screening at the bottom of the plinth to keep out pesky insects.

The four plinths that anchor the newel posts have a  $\frac{1}{8}$ -in. hole drilled through each corner. First we fill these holes with epoxy, and when it is dry we drill smaller holes through the epoxy for mounting screws. This effectively creates an epoxy gasket that prevents moisture from entering. We use galvanized 3-in. drywall screws to mount the newel plinths to the deck and the stairs. The plinths used under the columns are held in place by the weight of the porch roof and the beam.

Newel posts also need to be vented at the top, just like the columns. We start with a  $\frac{3}{4}$ -in. plywood subcap for each newel; we cut these to overhang the newels by  $\frac{3}{8}$  in. on each side. We then cut a 3-in. semicircular bite out of each side of the subcap. A 1-in. wide ogee molding hides the edges of the subcaps. A beveled cap made from  $\frac{3}{4}$ -in. clear pine is then fastened to each subcap, with a  $\frac{3}{8}$ -in. overhang on all sides. Construction adhesive alone is used to install the finish caps to eliminate any nail holes and possible water infiltration. Once assembled,
